Name Of Dam: DOUTHAT DAM

Location: BATH COUNTY, VIRGINIA.

PHASE I INSPECTION REPORT

NATIONAL DAM SAFETY PROGRAM

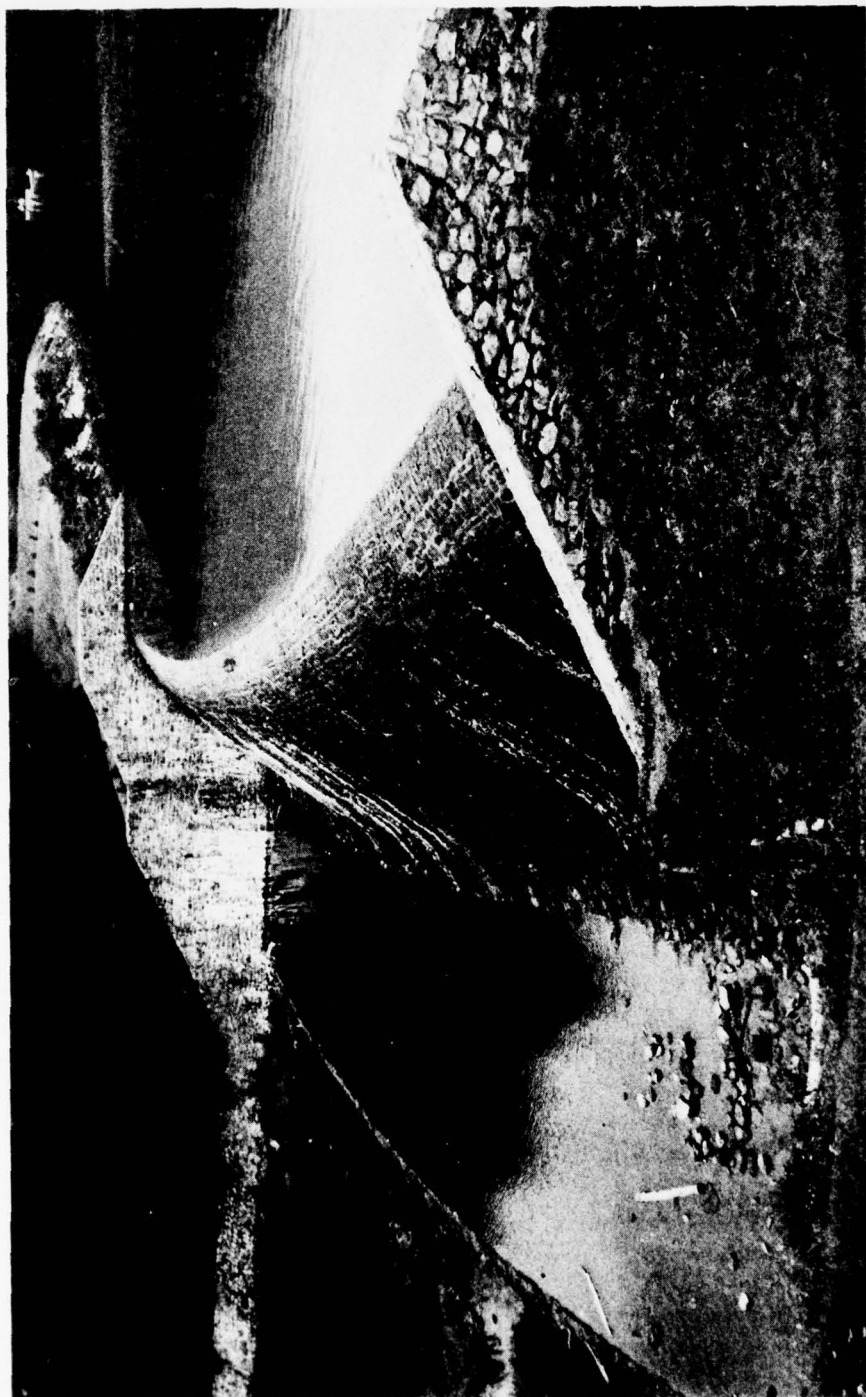
OVERVIEW PHOTO OF DOUTHAT DAM AND SPILLWAY

The crest and uppermost portion of the spillway surface appear to have been recently repaired. There are several missing stones in the masonry paving at the mid-height on the lower weir surface (see Overview Photo on the front page). A seepage condition exists in two areas of the spillway. One area is located on the lower mid-portion of the weir surface where concentrated red stains are shown. The other area lies at the base of the downstream endwall on the left end of the spillway with an estimated flow of 1 g.p.m. to 2 g.p.m.

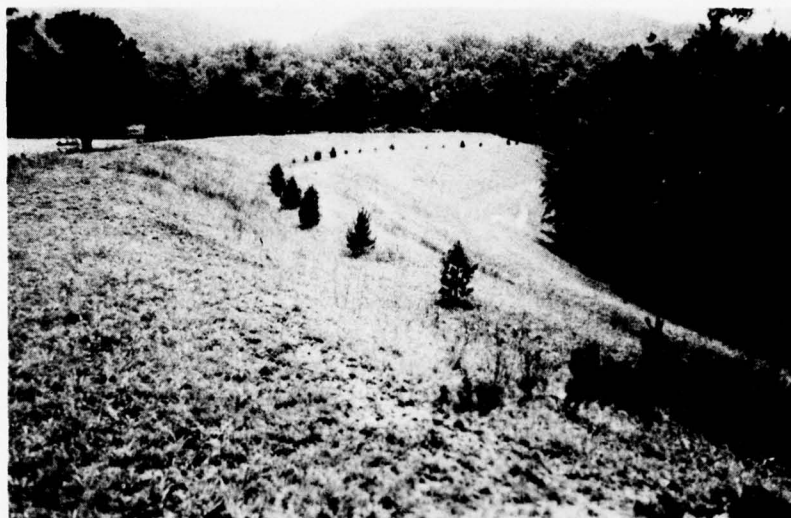
DOUTHAT DAM EMBANKMENT FROM RIGHT ABUTMENT

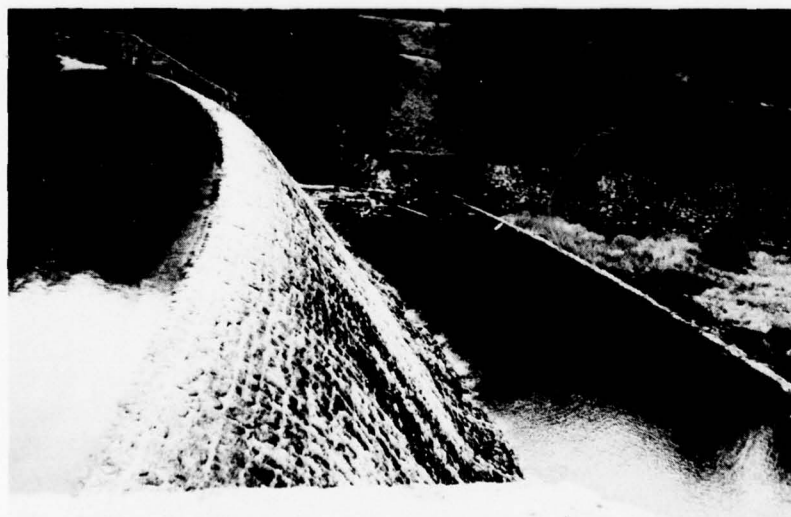
DOUTHAT DAM - VIEW OF SPILLWAY CREST

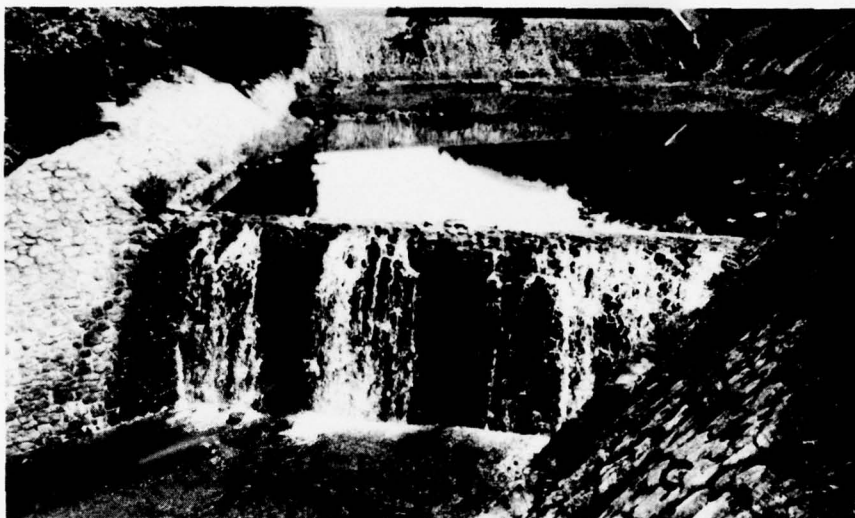
SPILLWAY DISCHARGE CHANNEL AND DOWNSTREAM PLUNGE POOL

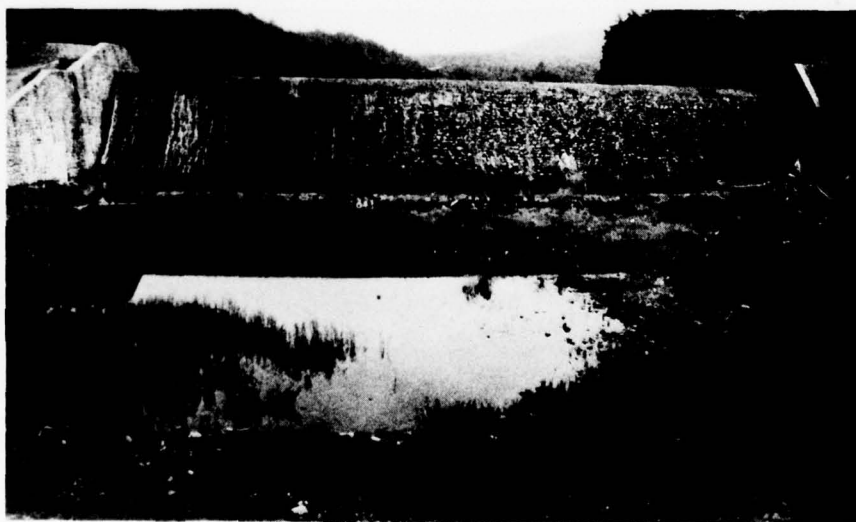
DOUTHAT DAM SPILLWAY

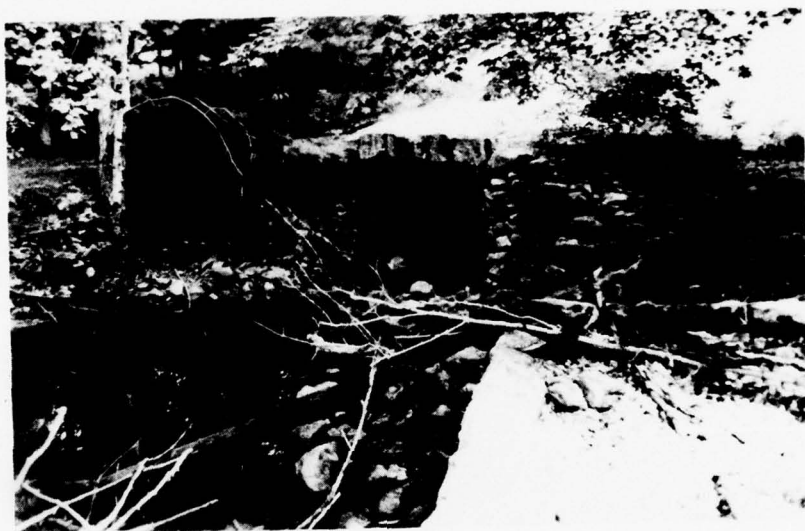
OUTLET END OF CONCRETE DISCHARGE TUNNEL
